**OHIO EPA  
TIME-CRITICAL REMOVAL ACTION  
REFERRAL PACKAGE**

A. Site Name: Meridian Automotive Systems, Inc

B. Location: 1020 East Main Street, Jackson, Ohio 45640

**MERIDIAN AUTOMOTIVE SYSTEMS  
JACKSON, JACKSON COUNTY, OHIO  
WASTE DESCRIPTIONS, 09/01/09**

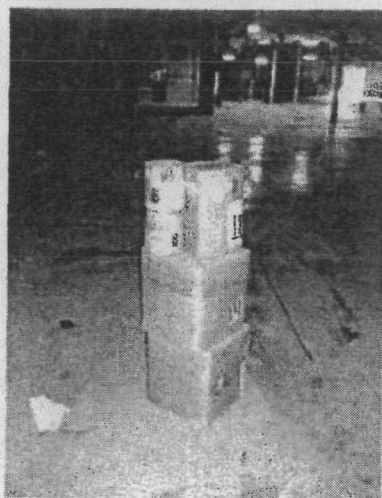
Waste Pesticides: A box of weed killer labeled Poison was abandoned.

PCB waste: Two cardboard boxes labeled "PCB transformer" were abandoned.

1. Cardboard boxes of weedkiller, and two boxes labeled "PCB transformer" (see photo #1)
2. Green 55-gallon drum (oil?) (See photo #2)
3. Black 55-gallon drum (oily waste). (see photo #3)

Photo 1 – Weed Killer and PCB transformers

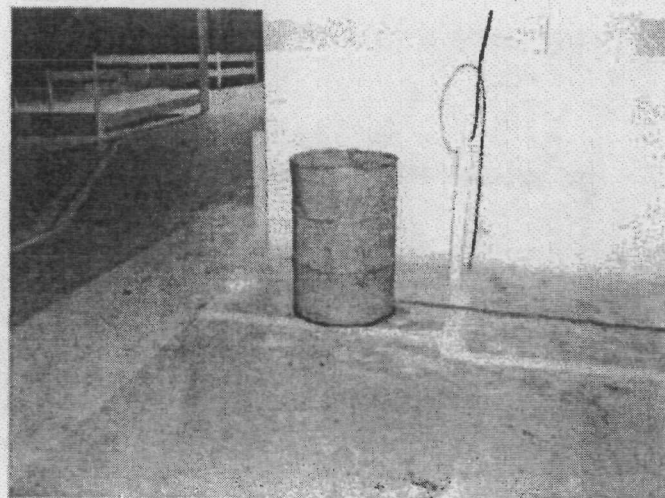
Photo 2 – Unknown drum believed to be oil waste

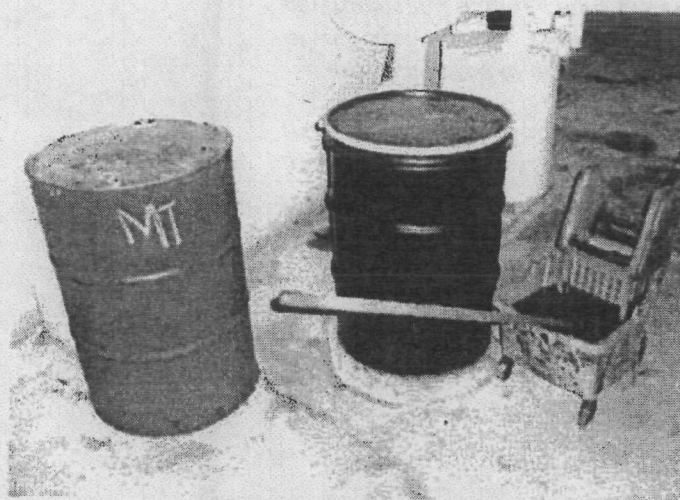
Photo 3 – Oily waste

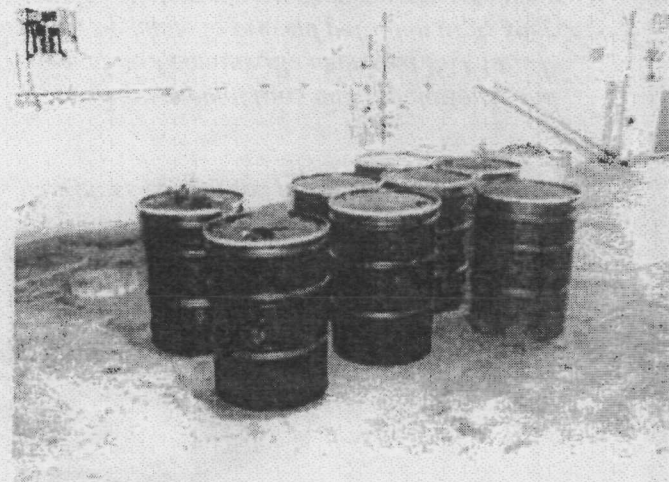
4. 8 55-gallon drums (oil?), mop bucket full of oil. (see photo #4)
5. Black 55-gallon drum (oily waste)
6. Group of containers: 1 drum of "Pliogrip 9100 adhesive"; 55-gallon drum of aerosol cans; two red "Shell Tellus" oil drums; note: oil on floor in this area. (see pic. #)

Photo 4 - Unknown waste believed to be used oil related

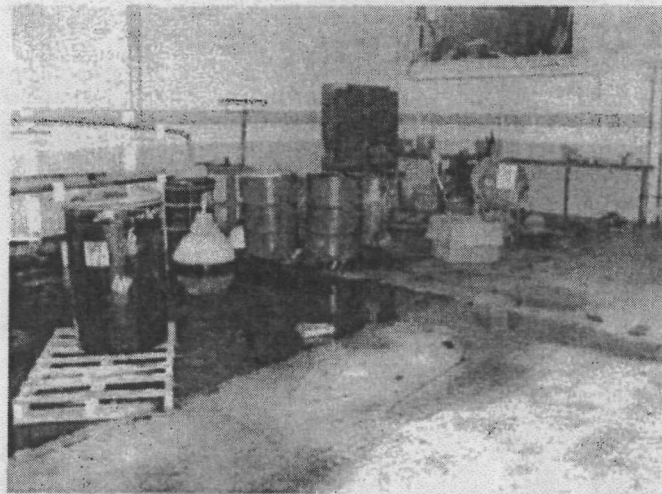
7. Parts cleaner: some sludge in the bottom of the Parts cleaner. Located in former maintenance shop. (see photo #5)
8. Box of aerosol cans in former maintenance area.

Photo 5 – Oil waste and aerosol can drums

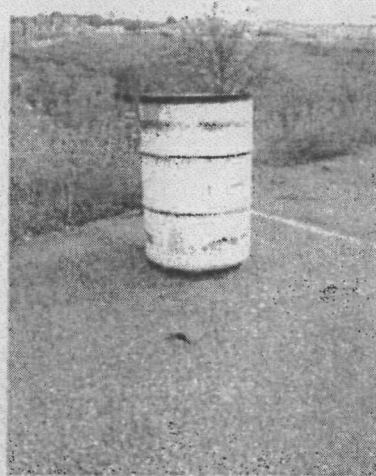
9. White drum outside, believed to contain primarily rain water – unknown. (See photo #6)
10. Drums of Pliogrip. (see photo #7)
11. Drum of white powder material (see photo #9)

Photo 6 – Unknown contents

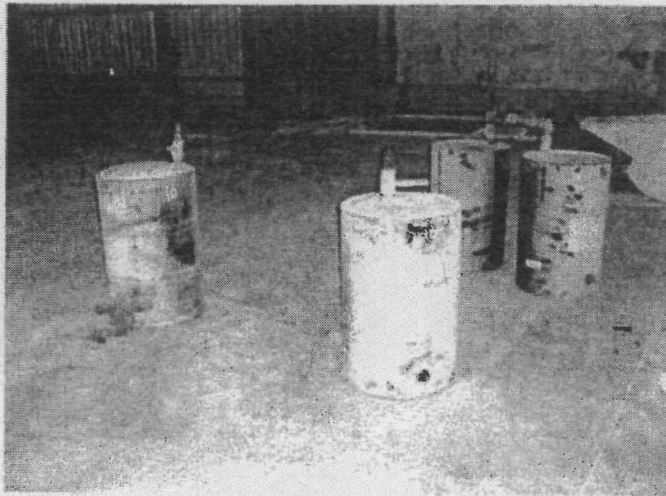
Photo 7 – Six pliogrip product drums

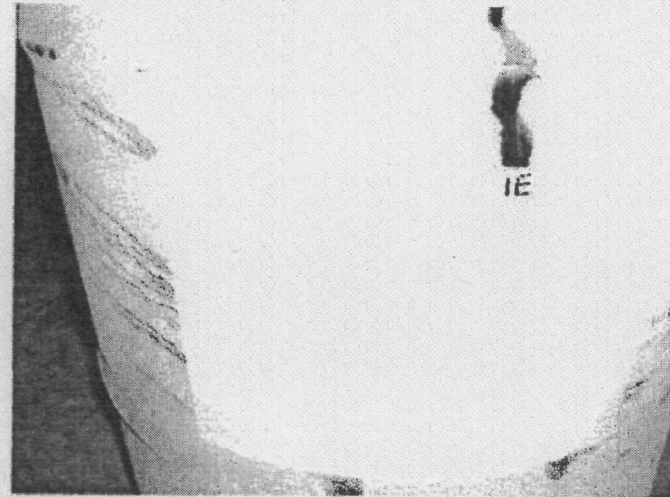
Photo 8 – Pliogrip label

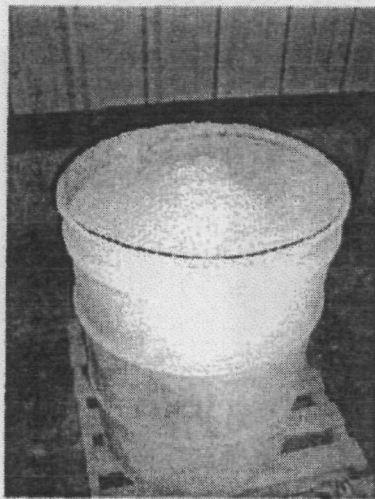
Photo 9 – Unknown white powder believed to be product

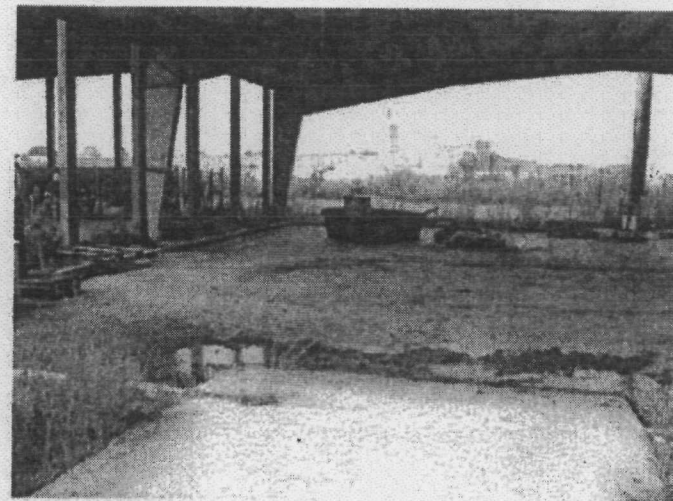
12. Former hazardous waste accumulation building (metal covered roof area) (see photo #10, 11)
13. Large fuel tanks. Uncertain if they contain any fuel oil. (see photo #12)

Photo 10 - Former HW storage building

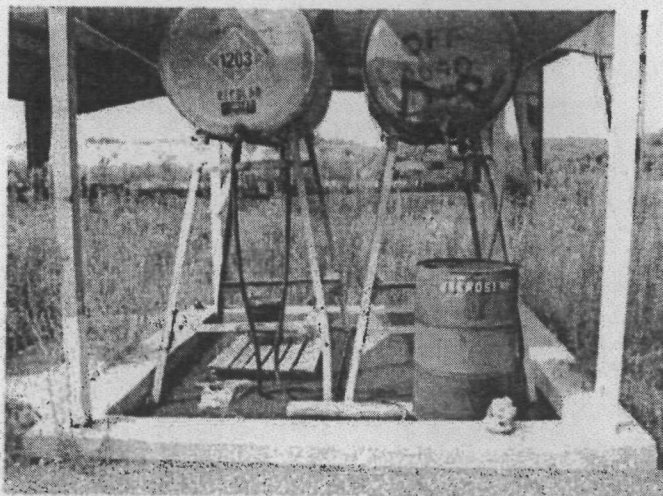
Photo 11 – Fuel tanks near former HW storage building

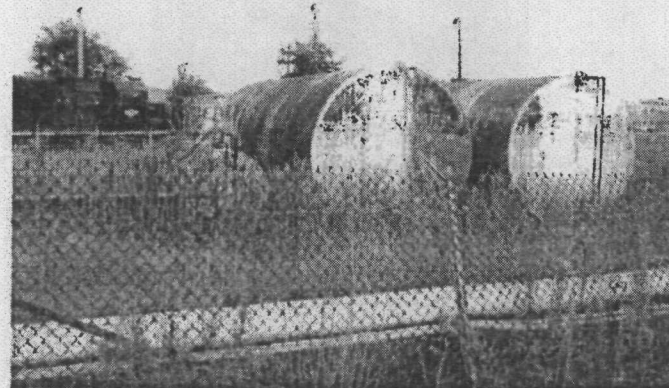
Photo 12 - Heating oil tanks

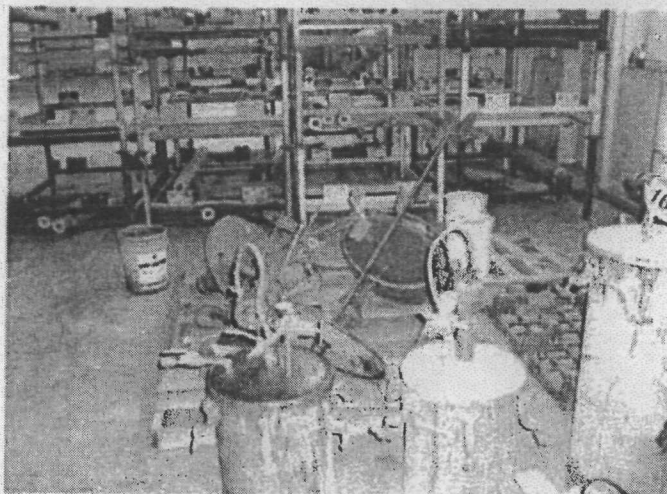
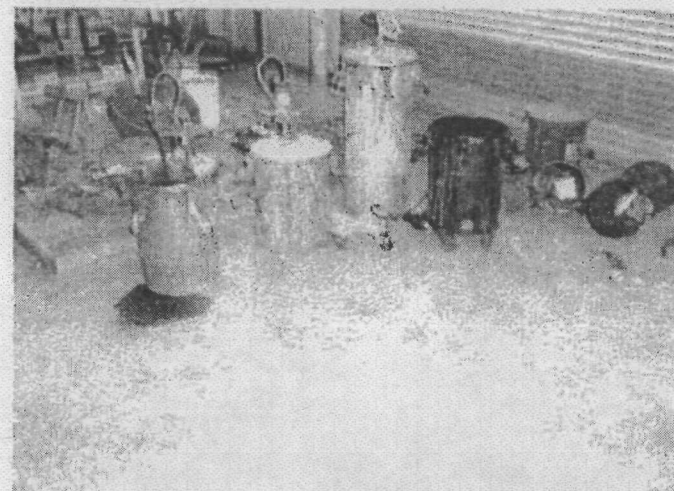
14. Paint mix room area and paint mix containers. (see photos #13, 14)
15. 55-gallon drum for aerosol cans (see photo #15)
16. Sheet Molding Compound (SMC) Mix Room. Contains mobile mix tubs, some of which contain liquids with strong volatile odor, presumably contain styrene (ingredient in SMC). Blue 55-gallon drum of styrene monomer. Small red containers presumably contain styrene as clean-up solvent. (see photos #16-19)

Photo 13 – Paint mix area, containers

Photo 14 – Paint mix area, containers

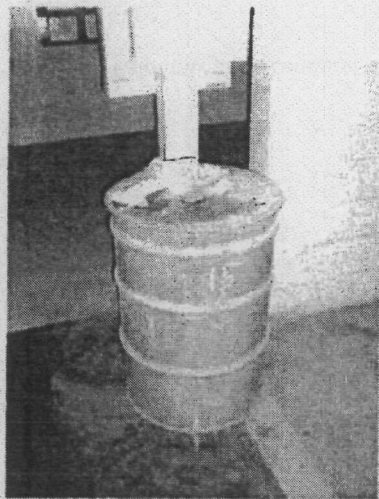
Photo 15 – HW drum for aerosol cans

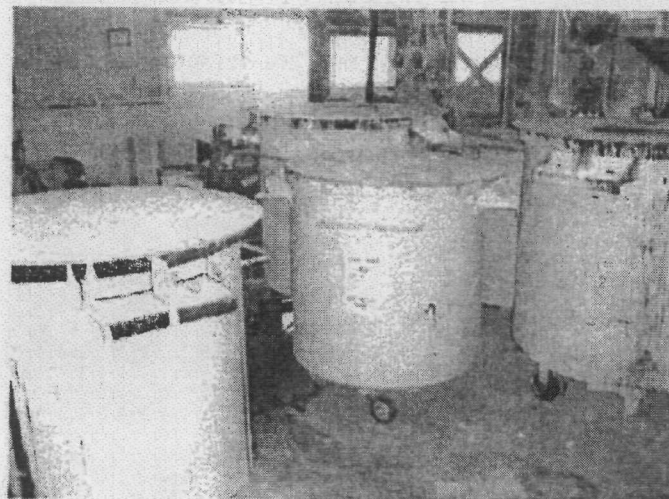
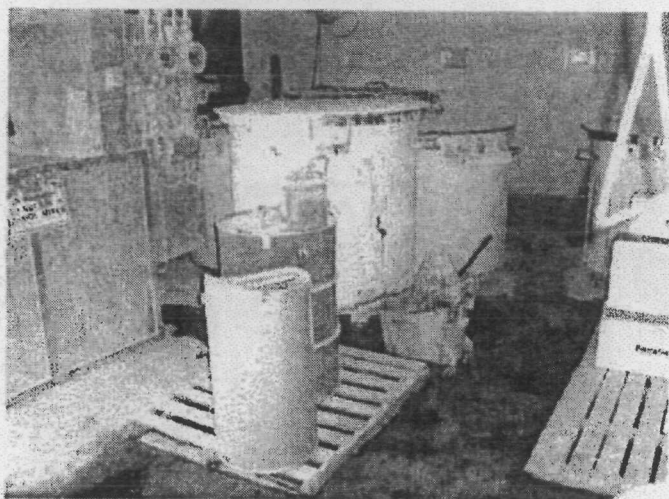
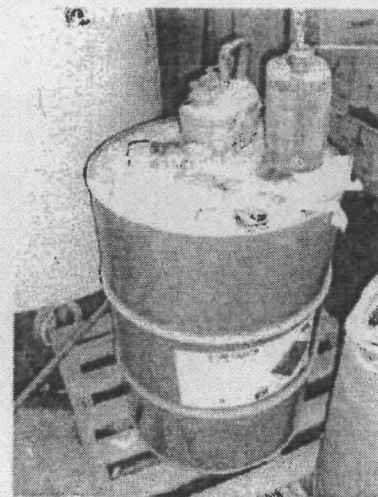
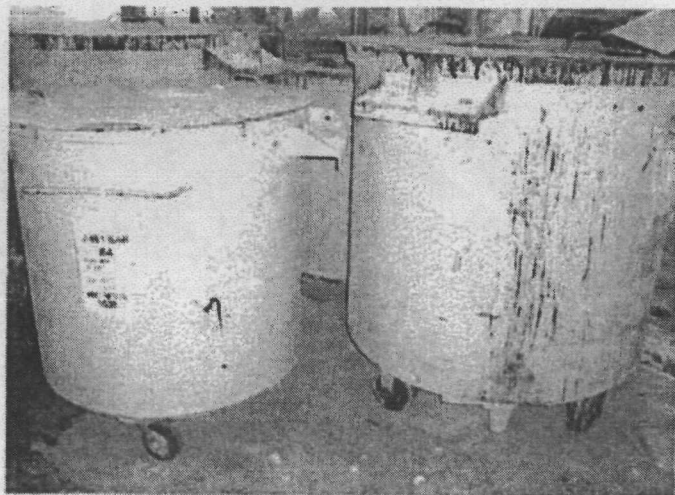
Styrene Monomer (Hazardous waste D001): There are several containers of D001 hazardous waste (styrene monomer) and at least one SMC mix container (estimated at 100 gallons) in the "SMC mix room", that is full of resin/solvent mixture.

Photo 16 - SMC mix room containers

Photo 17 – SMC mix room blue styrene drum

Photo 18 – SMC mix room small red containers (styrene)

Photo 19 – SMC mix room

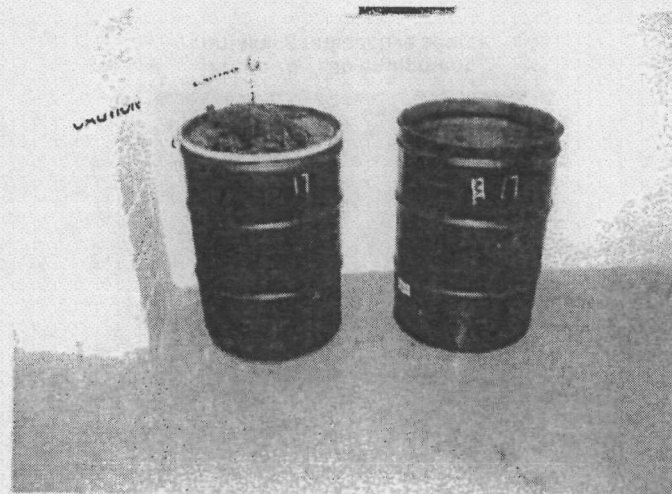
Photo 20 - Unknown drums near SMC mix room

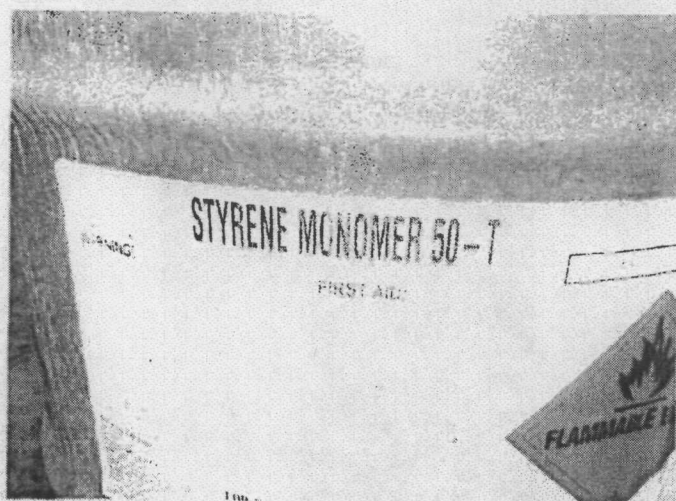
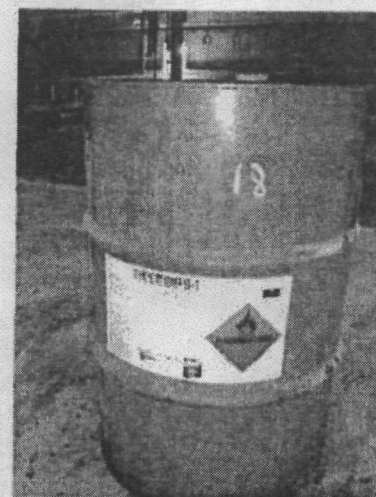
Photo 21 - Styrene monomer drum

Photo 22 - Styrene monomer drum

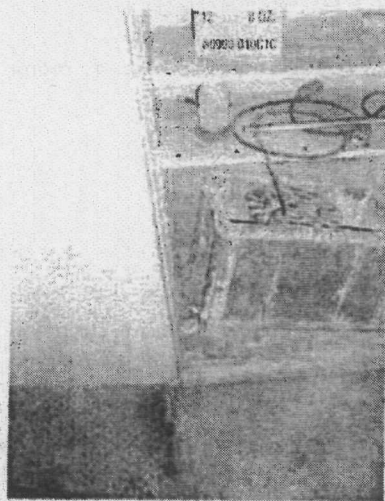
Photo 23 – Small containers in  
fire cabinet

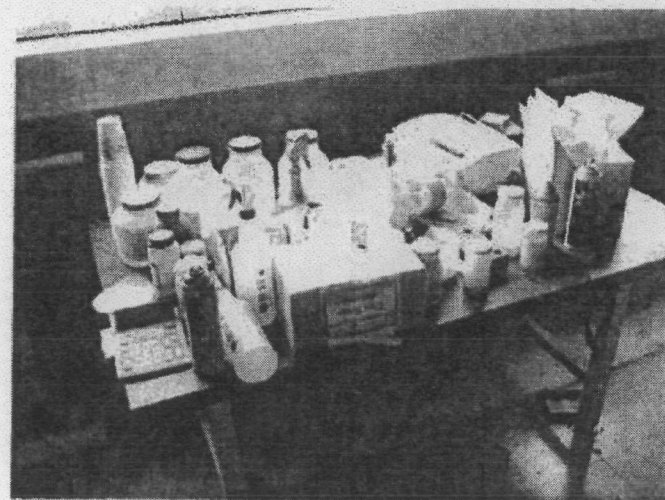
20. Former lab area. Numerous small containers, various liquids, chemicals, etc. (see photo #24)

Photo 24 – Miscellaneous lab bottles

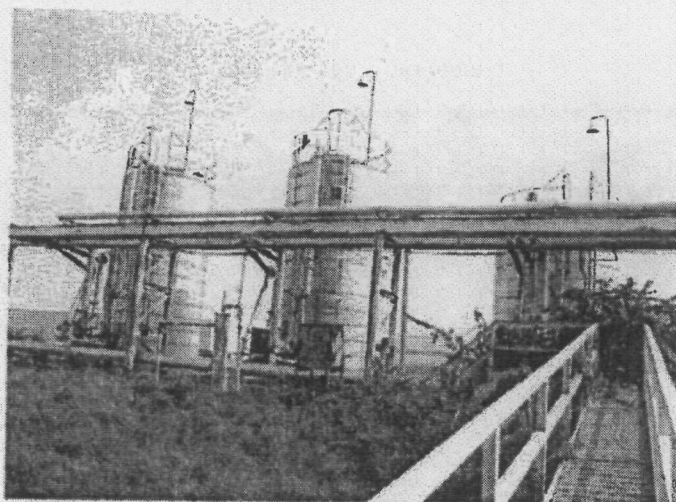
Photo 25 - Resin tank farm

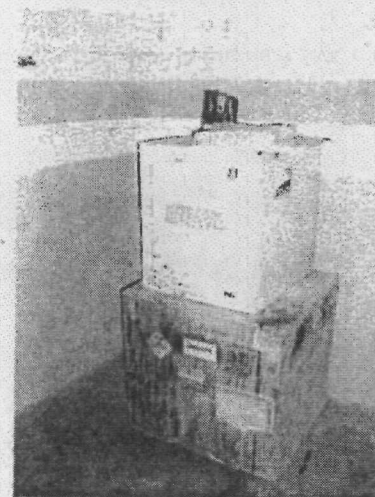
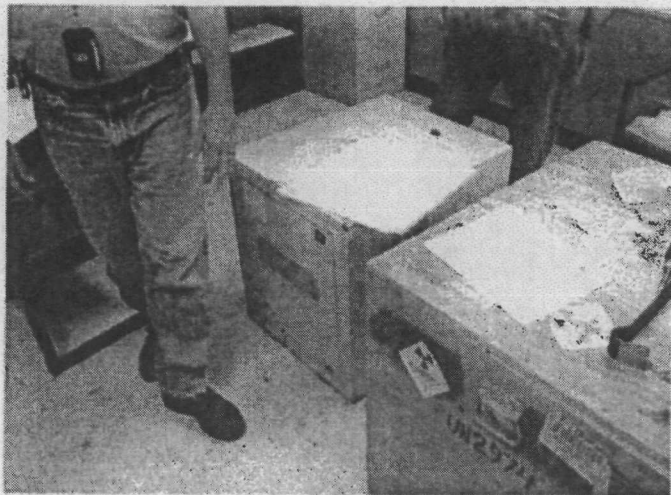
Radioactive Waste: An analytical instrument with a radioactive source used for evaluating the thickness and density of the fiberglass material product was abandoned on the site. Ohio Dept of Health personnel (Mr. Mike Snee and Mr. Tim Walker) visited the site on 8/26/09, to assess this instrument. ODH has contacted USEPA – radiological health personnel to arrange proper disposal of the radioactive source. This instrument is expected to be disposed of off-site during the week of August 31-Sept. 4, 2009.

Photo 26 - Lab equipment  
containing radioactive source

Photo 27 - Lab equipment containing radioactive source moved to locked office

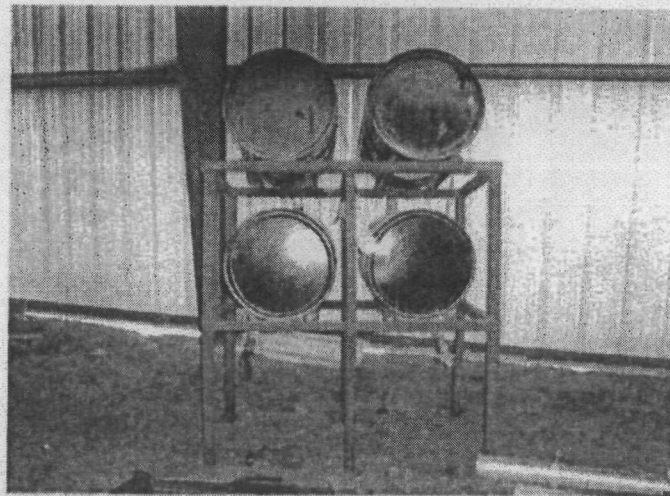
Photo 28 - Pliogrip drums

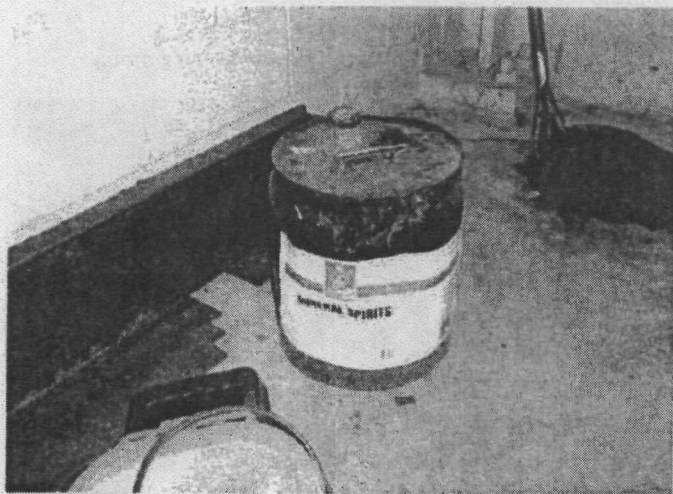
Photo 29 - Miscellaneous containers containing mineral spirits

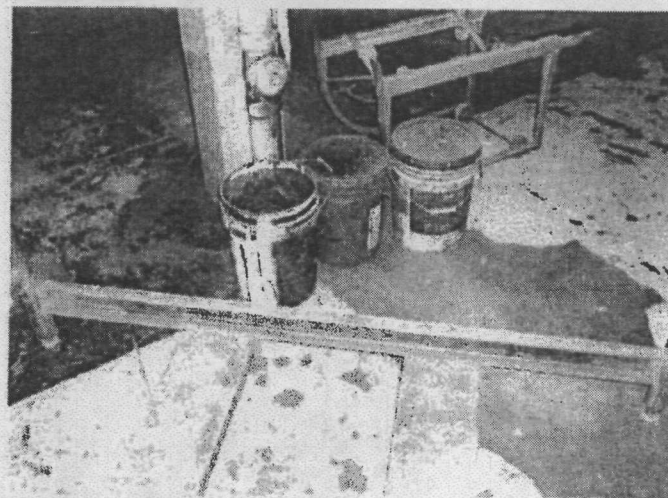
Photo 30 - Miscellaneous 5 gallon buckets

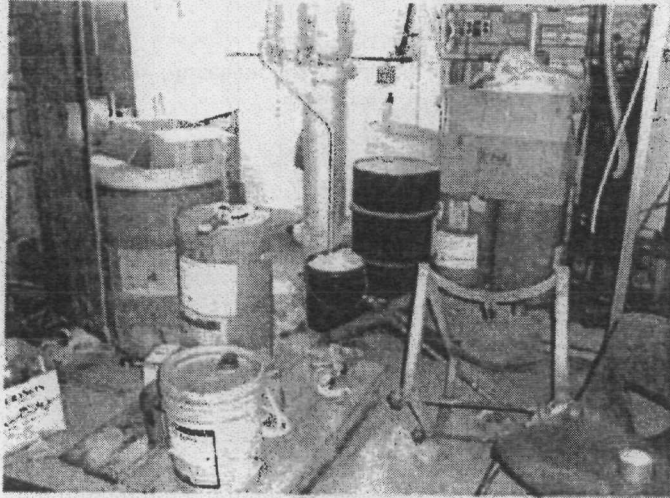
Photo 31 – Boiler room miscellaneous containers

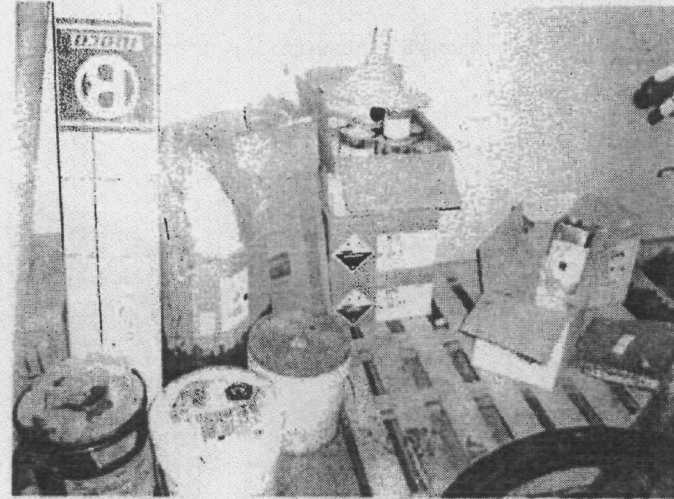
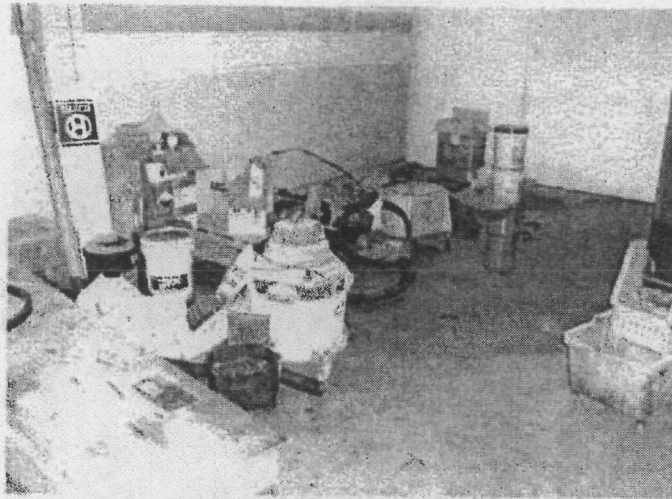
Photo 32 - Miscellaneous containers near waste location number 6

Photo 33 - Miscellaneous containers near waste location number 6

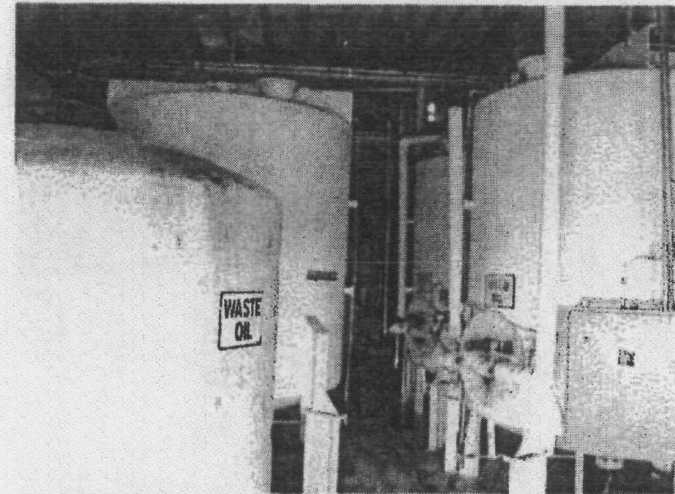
Photo 34 - Oil handling tanks all appear to be empty

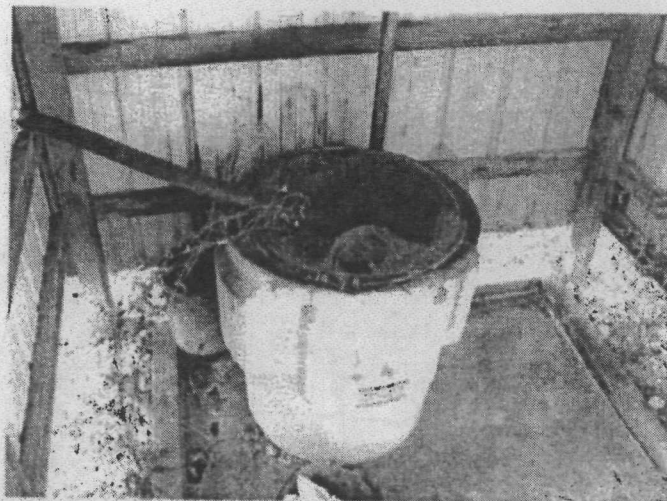
Photo 35 - Oil water skimmer shed with container full of oil

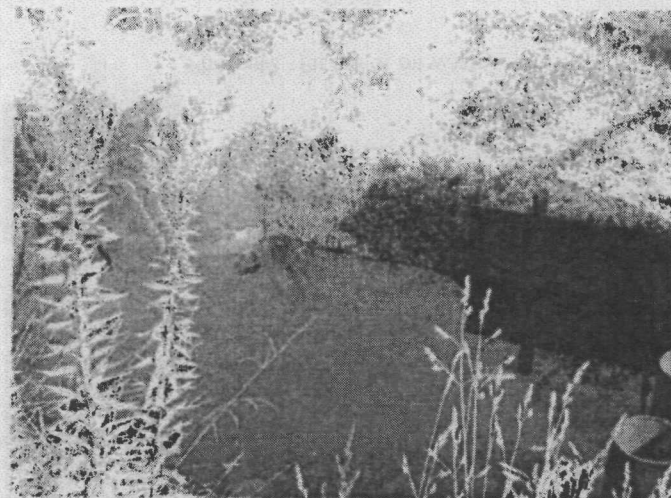
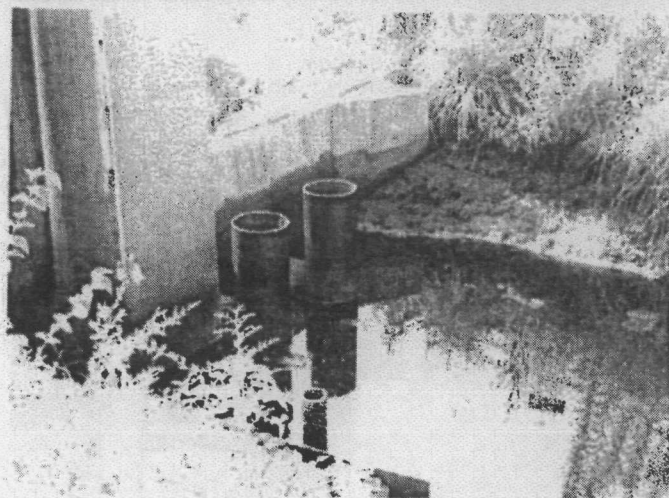
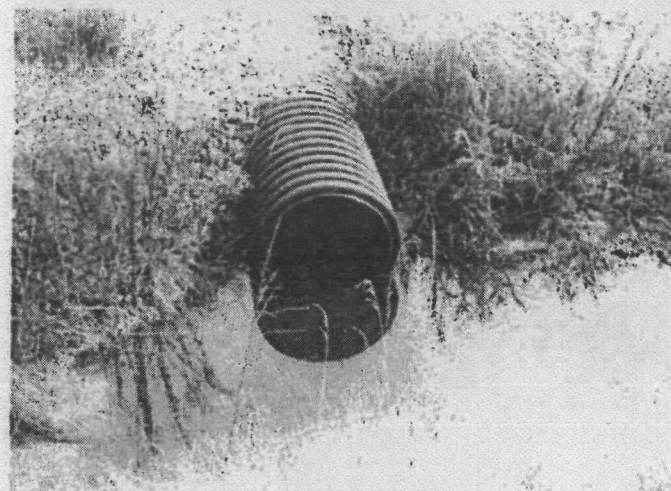
Ohio EPA personnel observed oil in a retention ditch leading from the facility. This ditch has an oil skimmer, but it is inoperable. A heavy rain could cause oil to migrate past the weir in the ditch. On August 28, 2009, approximately 1,000 gallons of oil/water mixture was pumped from the ditch to prevent off-site migration. See attached photographs.

Photo 36 - Oily sheen in ditch. On 8/29/09 oil/water mixture was pumped and containerized on site

Photo 37 - Oily sheen in ditch. On 8/29/09 oil/water mixture was pumped and containerized on site

Photo 38 - Oily sheen in ditch. On 8/29/09 oil/water mixture was pumped and containerized on site

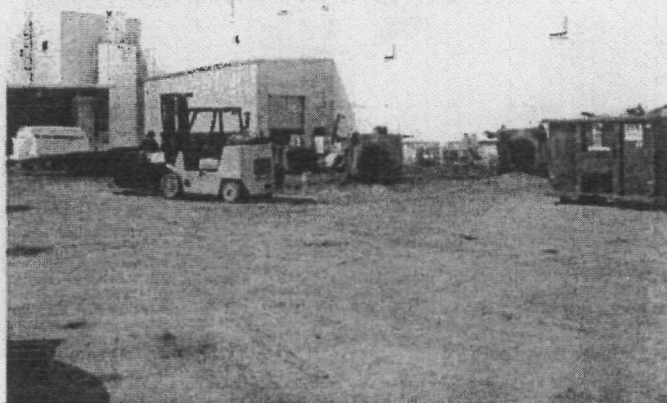
Photo 39 - Outside of plant where scrap steel contractor is working

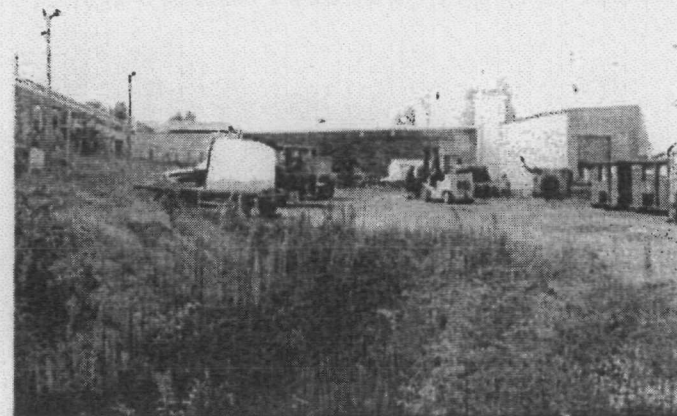
Photo 40 - Outside of plant

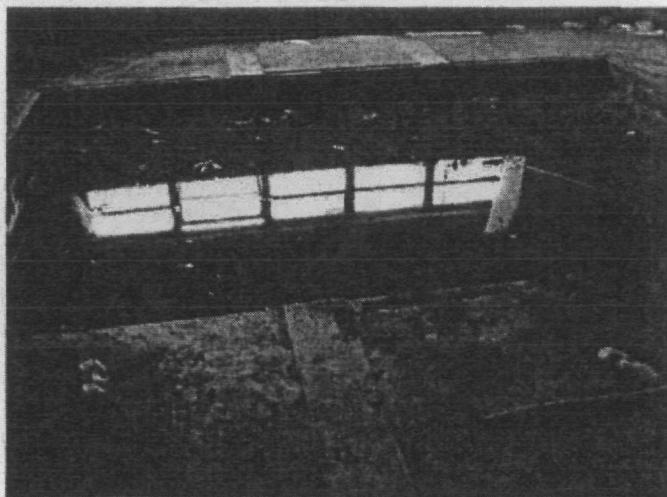
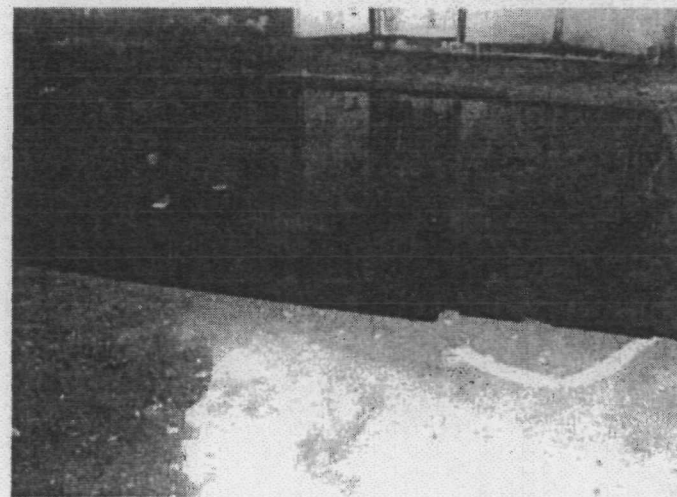
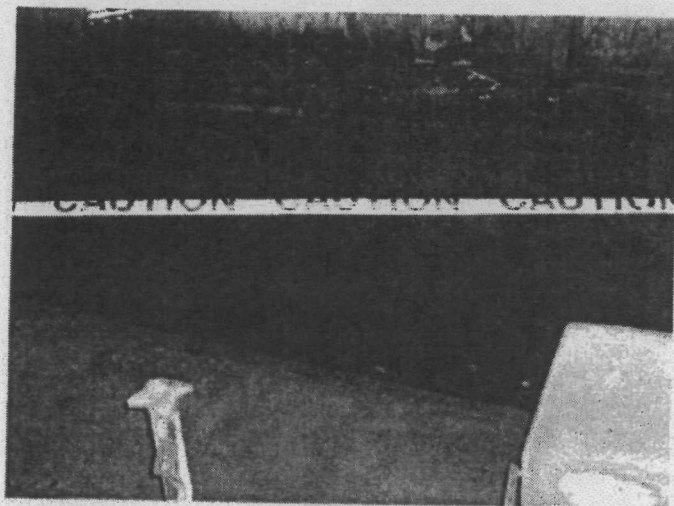
Used oil/water mixture: There are at least 20 hydraulic press pits/sumps on the property. Several pits are full to the top (see photographs) and numerous other pits have an unknown volume of oil or oil/water mixture. Also there are a large number of 55-gallon drums on-site that appear to have used oil in them. No waste analysis has been conducted and no estimates of volume have been developed. However, on-site contractors estimated that one of the pits full of liquid could total approximately 8,000 to 10,000 gallons of used oil/water. The used oil and water was generated from the disassembly of large hydraulic presses (pressure washing during disassembly). Also a containment ditch adjacent to the plant contained oil run-off on the water surface in the ditch. On August 28, 2009, approximately 1,000 gallons of oil/water mixture was pumped from the ditch to prevent off-site migration.

Photo 41 - Pit full of oil waste

Photo 42 - Pit full of oil waste

Photo 43 - Pit full of oil waste

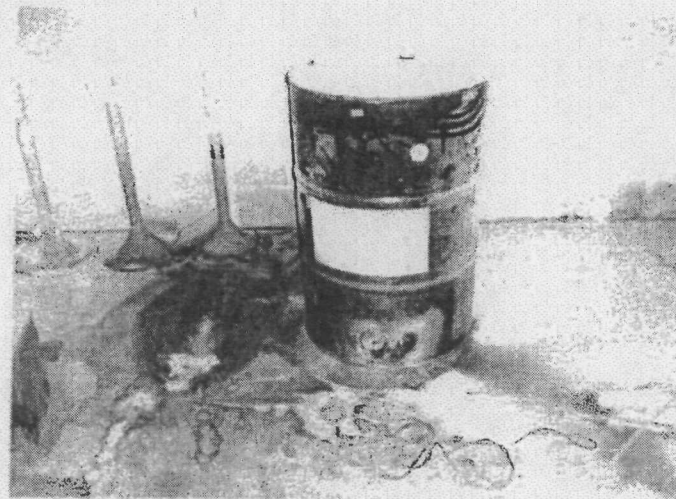
Photo 44 - Pliogrip drum

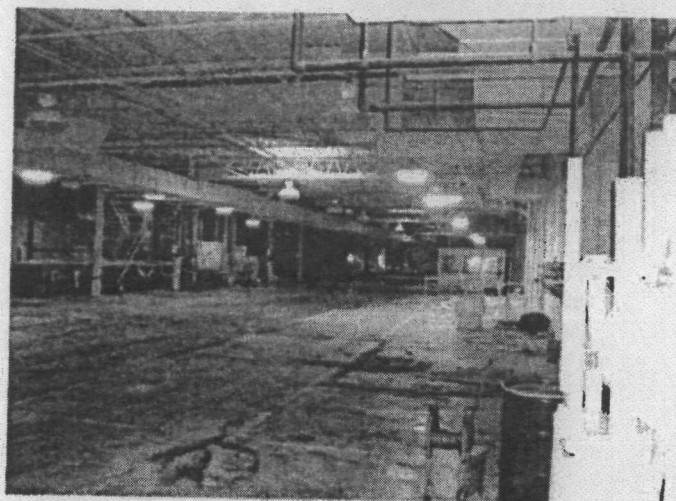
Photo 45 - Inside building looking down former press line
